Operating Experience Weekly Summary 97-20

May 9 through May 15, 1997

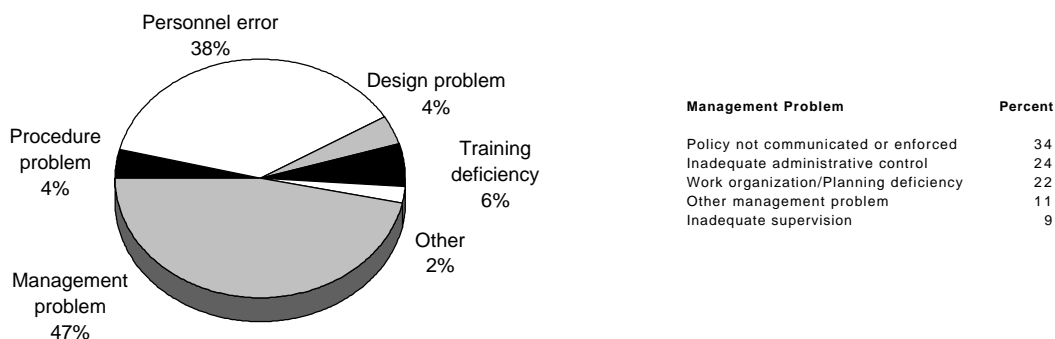
Figure 2-1. Root Causes of Electrical Shock Hazards Related to Procedure Violations or Work Planning Issues DOE-wide¹

Operating Experience and Feedback (OEAF) engineers reviewed the Occurrence Reporting and Processing System (ORPS) database for electrical shock hazards with the direct cause of inadequate work planning or procedure violations and found 186 reports. Personnel errors and management problems were cited as the root cause for 85 percent of the reports. This indicates that most electrical shock hazards are preventable. Figure

2-1 shows the root causes of the electrical shock hazards related to procedure violations or work planning issues DOE-wide from 1990 to present.

This event illustrates the need for work planners and coordinators to ensure that plans accurately describe the work activity and specifically identify tasks and equipment or components. Work plans should be made for the entire job before it starts and should not be completed piecemeal as the job progresses. DOE-STD-1050-93, *Guideline to Good Practices for Planning, Scheduling and Coordination of Maintenance at DOE Nuclear Facilities*, section 3.1.1.3, provides the key elements of an effective planning program. The standard includes guidance recommending that experienced individuals conduct thorough reviews of work plans to eliminate any errors or confusion. Managers at DOE facilities should review their programs to ensure that planners, craftsmen, and engineers understand their responsibilities and obligations.

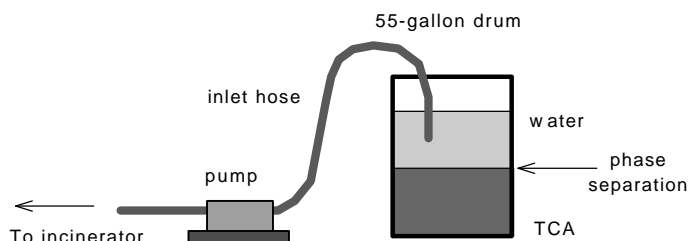
Figure 4-1. Method Used to Pump Water from Mixed Waste to Incinerator

In order to simulate actual operating conditions, operators used water extracted from low-level mixed waste. The primary ingredients of the mixed waste were trichloronaphthalene (TCA) and water. Operators poured the low-level mixed waste into a 55-gallon drum and allowed the waste to separate into TCA and water. Operators then pumped the water out of the drum, ensuring the inlet hose did not penetrate the TCA (see figure 4-1). Operators used this method successfully during a preliminary burn in January and an initial trial burn on May 8.

Before the May 9 trial burn, operators failed to observe phase separation in the drum and assumed there was no TCA present. They placed the inlet hose deep enough into the drum to penetrate the TCA area. When they ran the incinerator, the indicated concentration on the continuous emissions monitor rose rapidly and continued to spike high periodically for about 2 hours. Operators inspected the monitor and found high levels of condensation in some sample lines. Because they believed the waste fed to the incinerator was not the cause of the high hydrogen chloride levels, they assumed that the condensate in the sample lines had an adverse effect on the monitor. After the trial burn was completed, they sent a sample from an off-gas sample train to a laboratory for analysis. Laboratory technicians confirmed that the monitor indications were accurate.

This event illustrates the importance of accepting instrument readings and making conservative decisions when confronted with unexplained indications. In this event, if the operators had suspended the test until they received the results of the sample analysis, the violation would never have occurred. DOE 5480.19, *Conduct of Operations Requirements for DOE Facilities*, chapter III, section b.6, states: "Operators should believe instrument readings and treat them as accurate unless proven otherwise. Ignoring an unusual reading because an operator believes an instrument is faulty can cause abnormal conditions to be undetected. In general, operators should check other indications, if possible, when unexpected readings are observed." Managers at DOE facilities should ensure their personnel make conservative decisions and trust their instruments until proven otherwise.

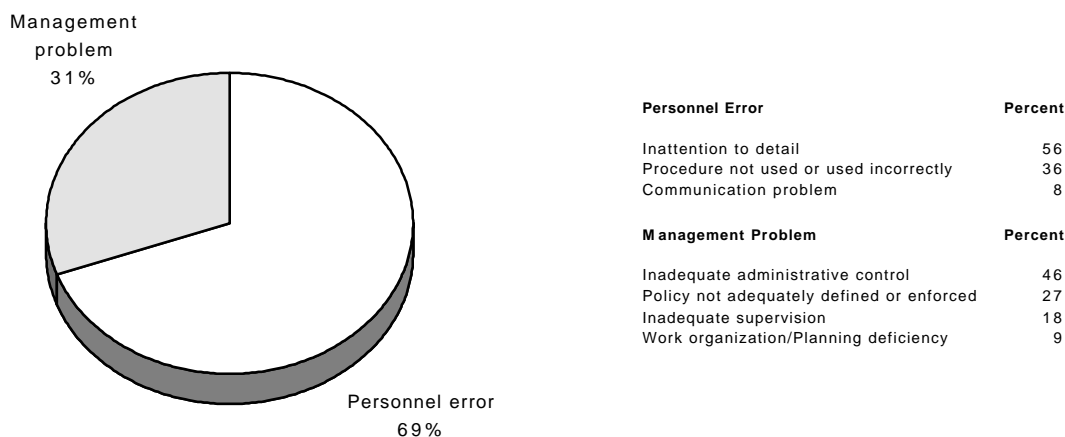
Figure 5-1. Distribution of Root Causes for Posting Violations¹

Operating Experience Analysis and Feedback (OEAF) engineers reviewed the Occurrence Reporting and Processing System (ORPS) database for reports involving violations of postings and found 36 occurrences. Figure 5-1 shows the distribution of root causes reported by facility managers for these events. Personnel error represented 69 percent of the root causes and management problems, 31 percent. Inattention to detail accounted for 56 percent of the personnel errors and inadequate administrative control accounted for 46 percent of the management problems.

These events underscore the importance of reading, understanding, and following the requirements of posted signs before opening doors or entering areas. Facility managers should ensure that access control signs are clearly worded, conspicuously posted, and always visible before entry. Personnel should be cautioned about propping open doors that can obscure postings. Surveillances should be conducted to verify that required postings are present and legible. Signs are important to facility residents and visitors because they provide information on (1) entry requirements, (2) notification requirements, (3) storage limits, and (4) health hazards, like chemicals, explosives, and radioactivity. DOE/EH-0256T, *Radiological Control Manual*, part 3, "Posting," contains requirements for posting of radiological areas. In addition, parts 601 through 603 of 10 CFR 835 establish requirements for posting radiological areas.
